Perforation of Internal Jugular Vein: An Avoidable Rare Complication in Permanent Haemodialysis Catheter Insertion

Abstract

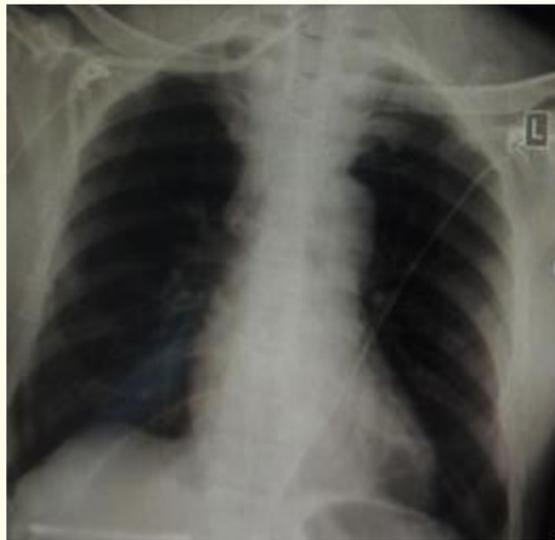
A chest radiograph revealed the catheter was displaced superiorly, with its tip in the internal jugular vein. A Doppler ultrasound of the neck showed a patent carotid artery with associated neck haematoma. As a result of the severe neck swelling, he developed difficulty breathing, leading to respiratory failure and emergent intubation. The following day, he developed sepsis with disseminated intravascular coagulation. He responded to antibiotics, vitamin K, and steroids.

Figure 1: Chest radiograph of haemodialysis catheter crossing midline.

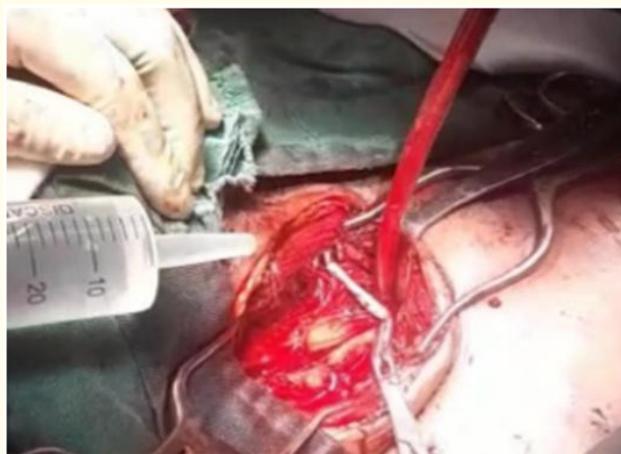
He underwent surgical exploration of the right neck by the cardiothoracic surgeon, revealing a perforated right internal jugular vein, with the catheter overlying the carotid artery. The catheter was removed and internal jugular vein repaired with subsequent resolution of the neck swelling.

Figure 2: Intra-op picture: catheter perforation of internal jugular vein.

Radiographs should be performed to confirm correct positioning of the catheter. In the event of great vessel perforation, management should be surgical, and removal of the catheter to minimise the risks of bleeding as demonstrated by our case study.
